**Flood Control Project Maintenance
Levee Inspections**
LMA District Cover Sheet
Spring 2019 Levee Inspection Results

Sacramento Maintenance Yard Willow Slough Bypass

Spring 2019 Levee Inspection Results

Waterway			Bank	Unit Miles
Unit No. 01 Willow Slough Bypass or North Levee			Left	5.05
	Spring (March - May)	Summer (June - August)	(September - November) Fall	Winter (December - February)
Unit Maintenance Rating (Fall Only)				
Date of Inspection	4/30/2019 - 4/30/2019			
DWR Inspector	Zach Jojola			
Accompanied By

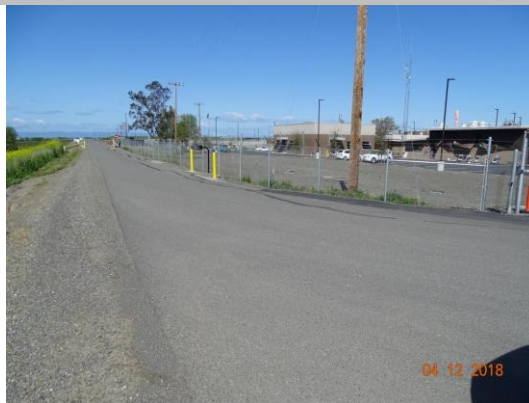
Photo 1 of 1 : SP_2019_ST0012_295_17_20190304_00006.jpg

View of fence on the landside shoulder. Spring 2018.

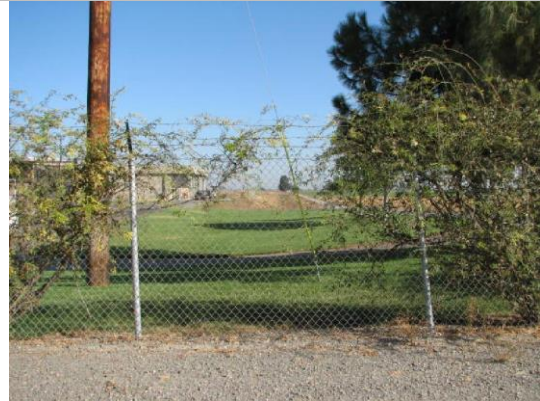
Photo 1 of 3 : UCIP_SP_2019_44903_22882.jpg

Landside view- beyond grass area see drainage inlet

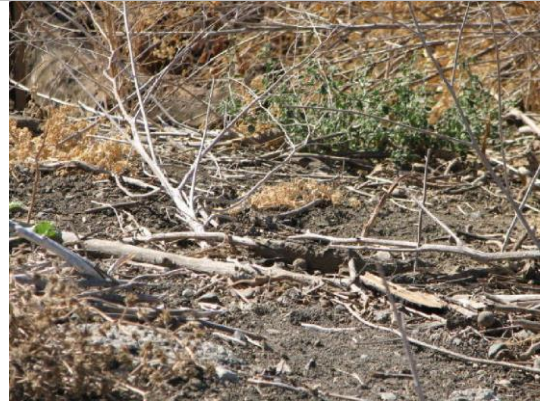
Photo 2 of 3 : UCIP_SP_2019_44903_22881.jpg

Waterside view- general view

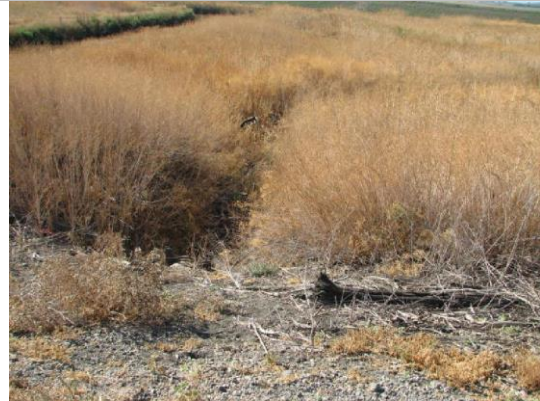
Photo 3 of 3 : UCIP_SP_2019_44903_22880.jpg

Waterside overview. Notice waterway.

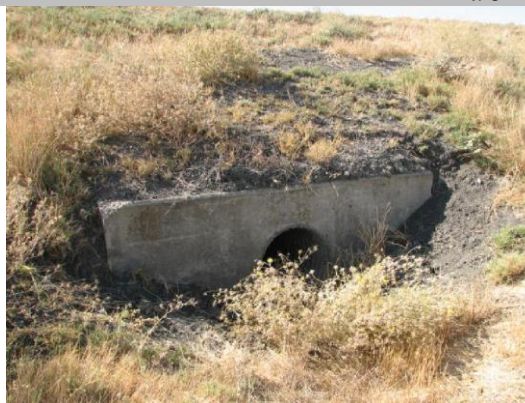
Photo 1 of 3 : UCIP_SP_2019_44907_22894.jpg

Comment Code					
Inspector Comment					
FS_ID:44907 DS_ID:17608 EP_NO: 10313 Repair Type: No Action Needed Crossing Status: Found UCIP Comments: 04/12/2017 LS - dump has it plugged, WS - ditch need to be established debris higher than water, inspected by JK, RF. (DWR Sacramento Yard - C. Lund) 09/19/2012 Pipe sits on concrete saddle on WS. (DWR UCIP - P. Amatya) FIELD_STRUCT_DESC: 24-inch corrugated metal drainage pipe through the levee, 13.5 feet below the crown. Flap gate is located on the waterside (WS) end. (24-inch pipe [HLM 0.79] authorized under Automatic Board Order (ABO) issued as Permit No. 10313, 1974 - Lear). [Additional Reference(s): DWR Levee Log, 1990. USACE Sacramento O&M Manual Unit 120, Willow Slough Channel Relocation and Levee Construction, February 1947, Drawing No. 50-4-2281 Sheet 2, 4 (Station 232+43)] FS Date: 5/5/2015 8:06:14 AM

Landside view- pipe and headwall

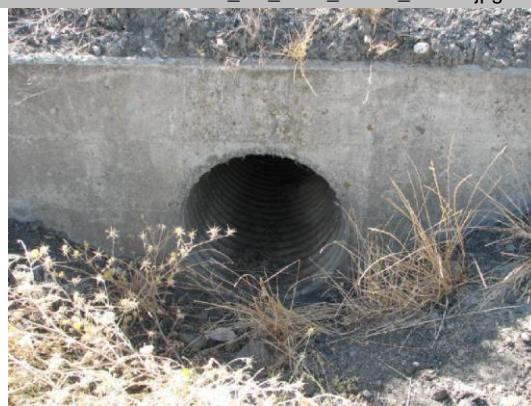
Photo 2 of 3 : UCIP_SP_2019_44907_22893.jpg

Landside view- pipe and headwall closer view

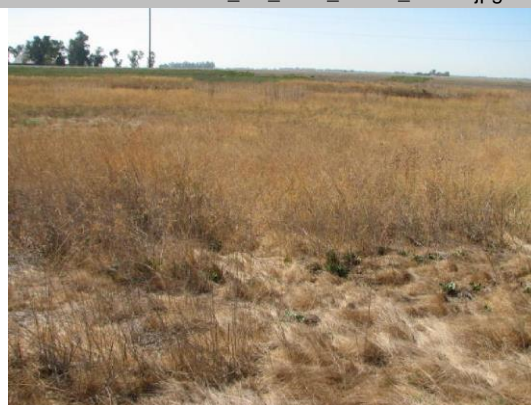
Photo 3 of 3 : UCIP_SP_2019_44907_22892.jpg

Waterside view

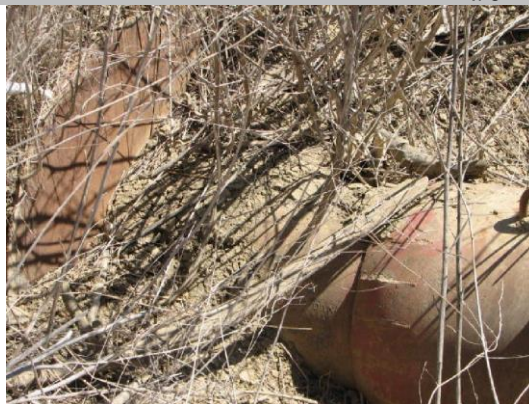
Photo 2 of 3 : UCIP_SP_2019_44929_22928.jpg

Waterside view- 20-inch pipe sleeved into 30-inch pipe

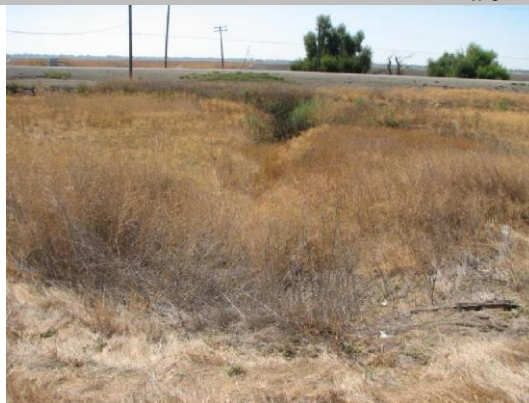
Photo 3 of 3 : UCIP_SP_2019_44929_22931.jpg

Waterside overview

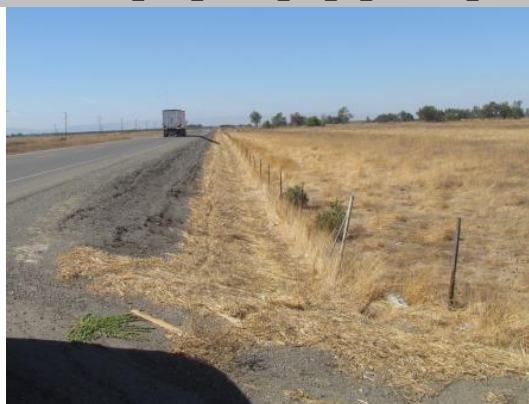
Photo 1 of 1 : SP_2019_ST0012_295_14_20190304_00005.jpg

LM Start	1.53	Rating **	M	Issue No.	14
LM End	2.20	Issue Type +	En	Location *	LS
Category	Earthen Levee			GPS Latitude/Longitude	
				Start	End
Item	Encroachments			38.590334 °	38.590466 °
				-121.693618 °	-121.705849 °
DWR ID	DWR_ST0012_01_f_2016_14				
Comment Code					
FE : Fence					
Inspector Comment					
There is a barbed wire fence along this section of levee.

View of fence encroaching 10-foot easement on landward side of the levee. Fall 2016.

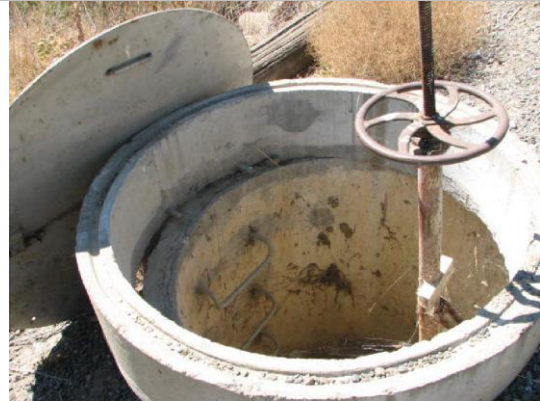
Photo 3 of 3 : UCIP_SP_2019_44937_22948.jpg

Waterside view- concrete manhole.

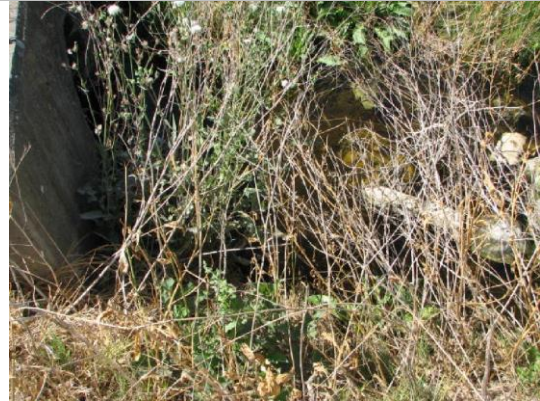
Photo 3 of 3 : UCIP_SP_2019_53861_22960.jpg

Landside view- vegetation around inlet.

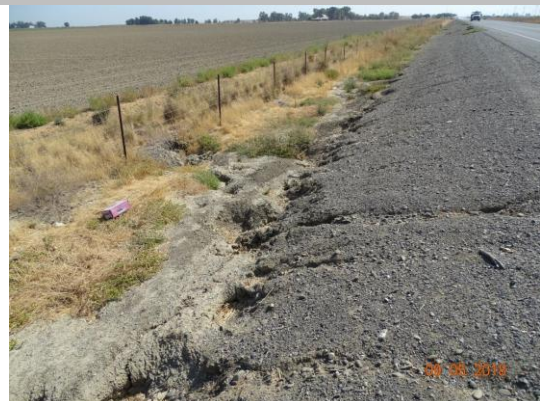
Photo 1 of 3 : SP_2019_ST0012_295_10_20190304_00002.jpg

LM Start	2.93	Rating **	M	Issue No.	10
LM End	3.00	Issue Type +	Ma	Location *	LS
Category	Earthen Levee			GPS Latitude/Longitude	
				Start	End
Item	Erosion / Bank Caving			38.590572 °	38.590653 °
				-121.719349 °	-121.720714 °
DWR ID	DWR_ST0012_01_s_2015_10				
Comment Code					
E1 : Note and monitor erosion site.					
Inspector Comment					
There appears to be runoff on the landside slope. It possibly could be from an abandoned pipeline that is caving in.

Updated view of the erosion on the landside slope. Fall 2018.

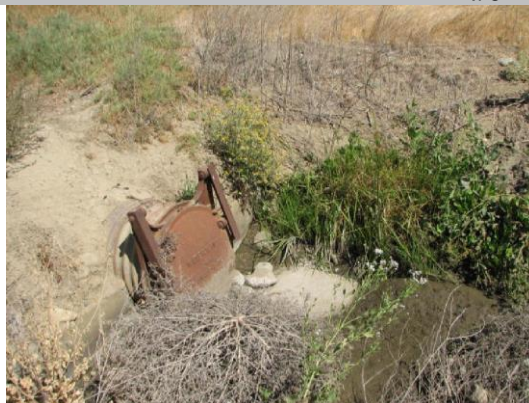
Photo 1 of 3 : UCIP_SP_2019_53862_22967.jpg

Comment Code					
Inspector Comment					
FS_ID:53862 DS_ID:17621 EP_NO: 10312 Repair Type: Urgent Crossing Status: Found UCIP Comments: 04/09/2019 Internal inspection has been completed and inspection shows major erosion on the WS outlet. Recommend complete removal and replacement. Pipe is in a section of major county road (Road 29). (J. McCabe - DWR Sacramento Yard) 04/12/2017 good/clear on LS & WS, inspected by JK, RF. (DWR Sacramento Yard - C. Lund) 09/19/2012 Depressions on waterside slope of the levee. (DWR UCIP - P. Amatya) FIELD_STRUCT_DESC: 24-inch corrugated metal drainage pipe through the levee, 10 feet below the crown. Flap gate is located on the waterside (WS) end. (24-inch pipe [HLM 3.08] authorized under Automatic Board Order (ABO) issued as Permit No. 10312, 1974 - Kelly). [Additional Reference(s): DWR Levee Log, 1990. USACE Sacramento O&M Manual Unit 120, Willow Slough Channel Relocation and Levee Construction, February 1947, Drawing No. 50-4-2281 Sheet 1 (Station 110+97)] FS Date: 4/9/2019 8:27:00 AM

Waterside view- pipe and flap gate.

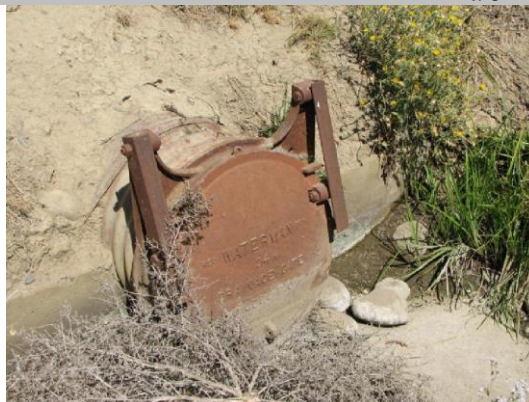
Photo 2 of 3 : UCIP_SP_2019_53862_22970.jpg

Waterside view- pipe and flap gate (close view).

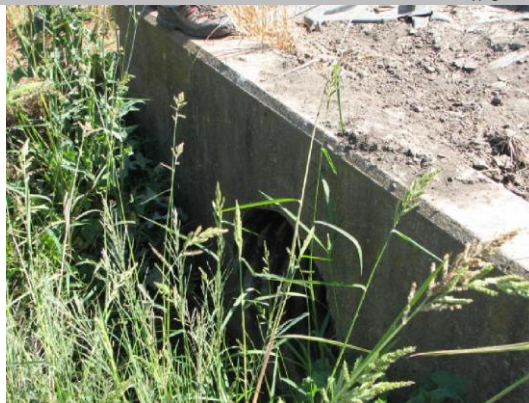
Photo 3 of 3 : UCIP_SP_2019_53862_22969.jpg

Landside view- pipe and concrete headwall.

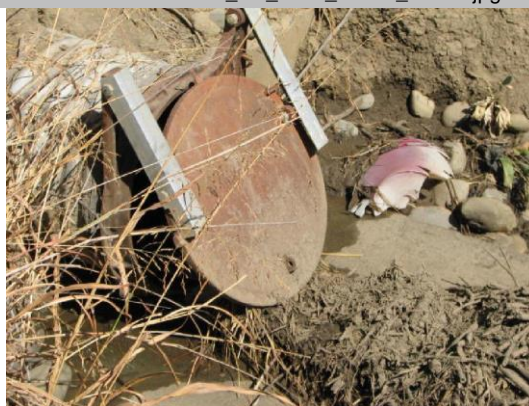
Photo 3 of 3 : UCIP_SP_2019_44947_22986.jpg

Comment Code						
Inspector Comment						
FS_ID:44947						
DS_ID:17622						
EP_NO: 10316						
Repair Type: No Action Needed						
Crossing Status: Found						
UCIP Comments: 04/12/2017 good/clear on LS & WS, inspected by JK, RF. (DWR Sacramento Yard - C. Lund)						
05/28/2013 Debris on waterside flap gate has been removed. (DWR Sacramento Yard - C. Lund)						
09/19/2012 Debris on waterside flap gate. Needs debris removal from the pipe. (DWR UCIP - P. Amatya)						
FIELD_STRUCT_DESC: 24-inch corrugated metal drainage pipe through the levee, 11 feet below the crown. Flap gate is located on the waterside (WS) end. Concrete pad is located on the WS. (24-inch pipe [HLM 3.57] authorized under Automatic Board Order (ABO) issued as Permit No. 10316, 1974 - Stafford). [Additional Reference(s): DWR Levee Log, 1990. USACE Sacramento O&M Manual Unit 120, Willow Slough Channel Relocation and Levee Construction, February 1947, Drawing No. 50-4-2281 Sheet 1 (Station 85+00)]

Waterside view- pipe, flap gate and debris. The pipe sits on concrete saddle.

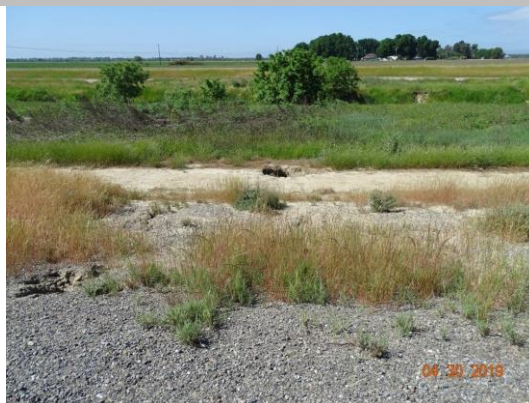
Photo 1 of 1 : SP_2019_ST0012_295_23_20190430_00031.jpg

LM Start	3.69	Rating **	A/W	Issue No.	23
LM End	3.69	Issue Type +	Ma	Location *	WS
Category	Earthen Levee			GPS Latitude/Longitude	
				Start	End
Item	Animal Control			38.591699 °	38.591699 °
				-121.733066 °	-121.733066 °
DWR ID	DWR_ST0012_01_s _ 2019_23				
Comment Code					
A3 : No rodents visible, but rodent burrows visible; need to backfill and compact or grout burrows.					
Inspector Comment					
There is a possible beaver den on the waterside toe road. It is not in the levee prism. Recommend monitoring for activity.

View of hole on the toe road. Spring 2019.

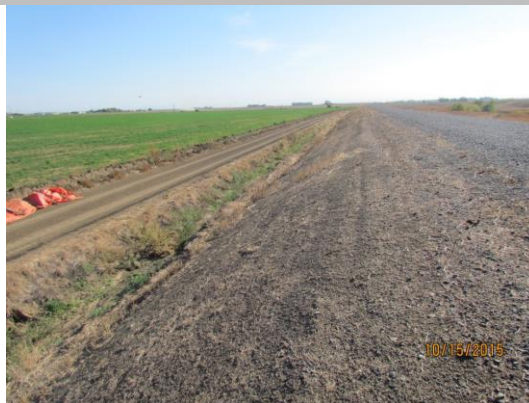
Photo 1 of 1 : SP_2019_ST0012_295_4_20190304_00001.jpg

LM Start	4.12	Rating **	M	Issue No.	4
LM End	4.60	Issue Type +	En	Location *	LS
Category	Earthen Levee			GPS Latitude/Longitude	
				Start	End
Item	Encroachments			38.596784 °	38.599845 °
				-121.737662 °	-121.744830 °
DWR ID	DWR_ST0012_01_s _ 2012_4				
Comment Code					
DT : Ditch					
Inspector Comment					
A ditch is at the levee toe.

View of the ditch on the landward side of the levee looking downstream.
Fall 2015.

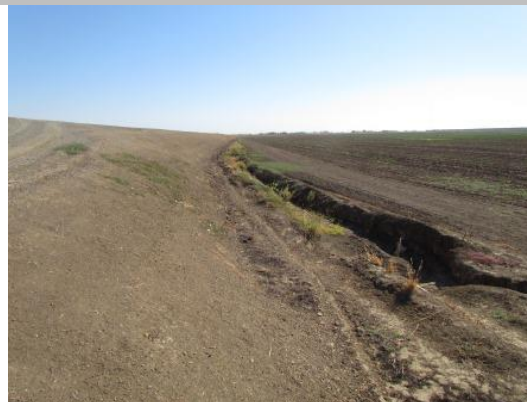
Photo 1 of 2 : SP_2019_ST0012_296_7_20190304_00002.jpg

A view of the ditch near LM 0.29. Fall 2016.

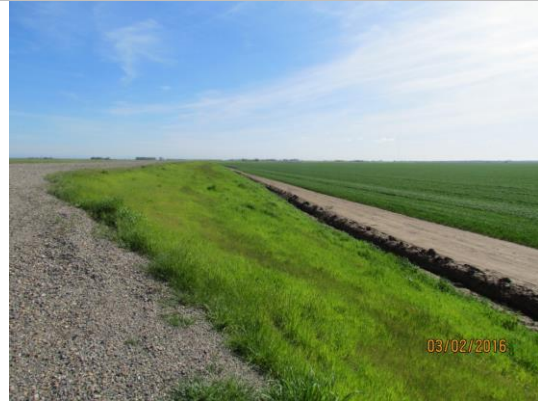
Photo 2 of 2 : SP_2019_ST0012_296_7_20190304_00003.jpg

View of the ditch on the landward side of the levee looking downstream.
Spring 2016.

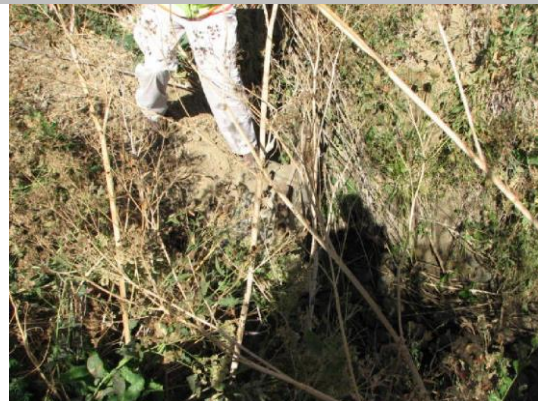
Photo 1 of 3 : UCIP_SP_2019_45286_22464.jpg

Waterside view- concrete headwall and CM pipe

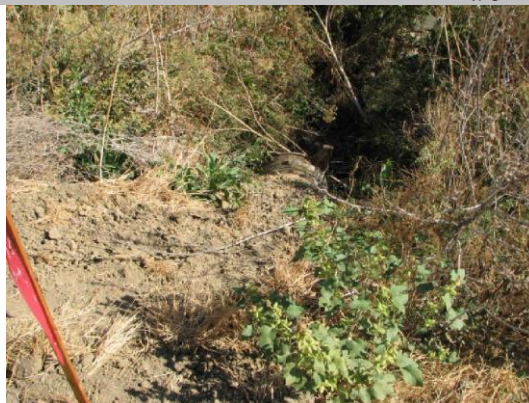
Photo 2 of 3 : UCIP_SP_2019_45286_22460.jpg

Waterside view- overview

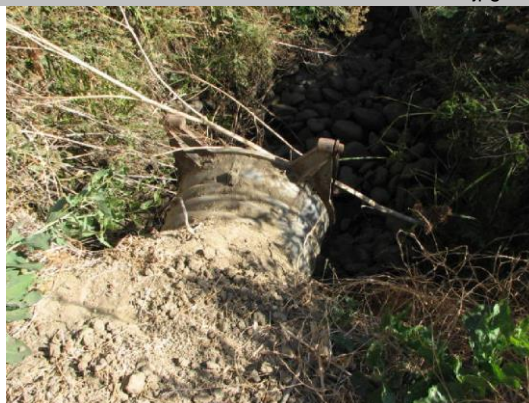
Photo 3 of 3 : UCIP_SP_2019_45286_22461.jpg

Waterside view- CM pipe and flap gate.

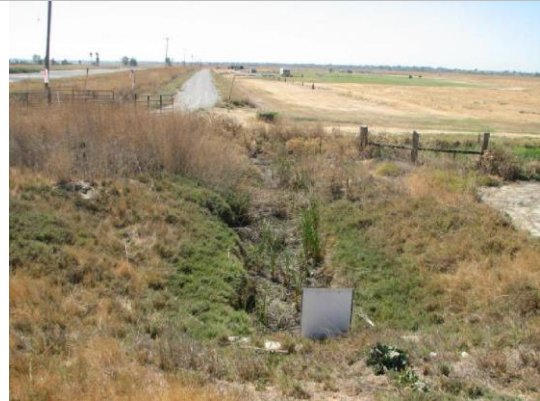
Photo 3 of 3 : UCIP_SP_2019_45291_22477.jpg

Landside view- open ditch.

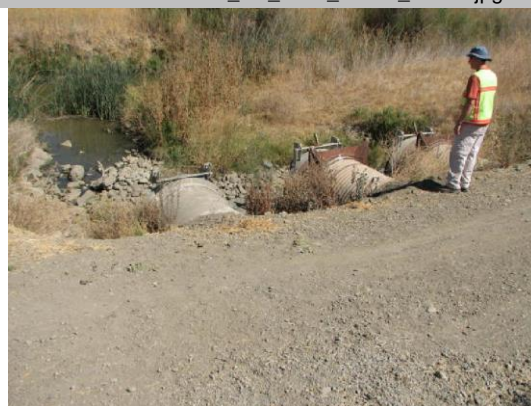
Photo 1 of 3 : UCIP_SP_2019_45294_22789.jpg

Waterside overview- middle 42-inch pipe.

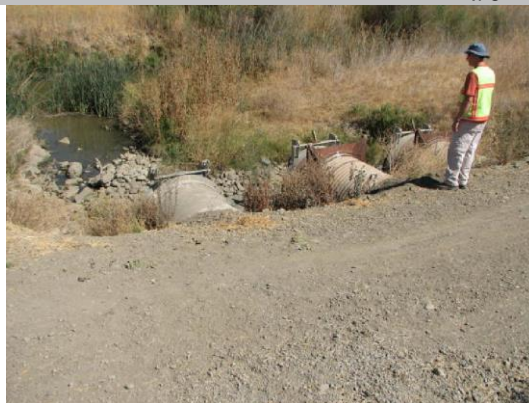
Photo 1 of 3 : UCIP_SP_2019_45295_22794.jpg

Waterside overview- far right 42-inch pipe.

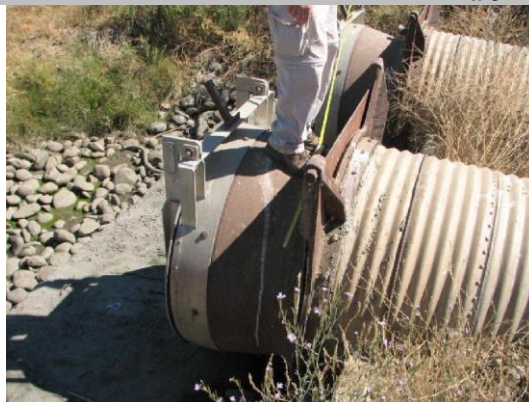
Photo 2 of 3 : UCIP_SP_2019_45295_22793.jpg

Waterside view- 42-inch steel pipe and flap gate (right).

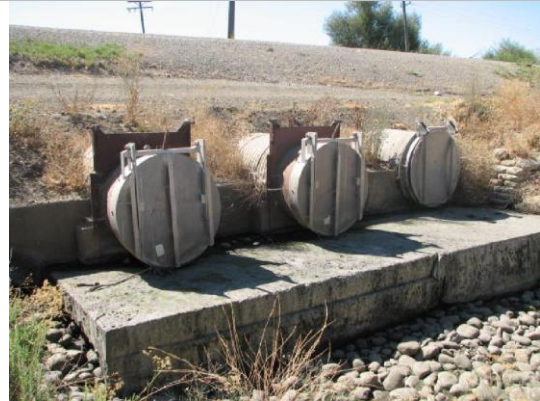
Photo 3 of 3 : UCIP_SP_2019_45295_22796.jpg

Waterside overview- outlet structure.

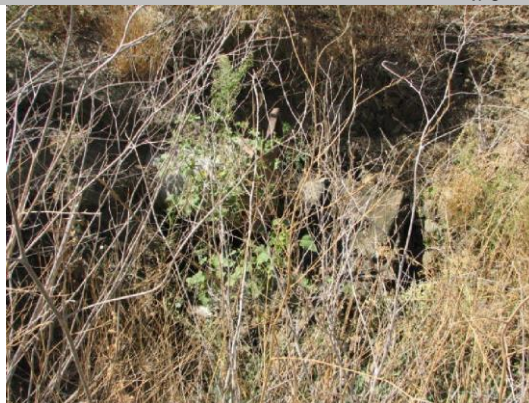
Photo 1 of 3 : UCIP_SP_2019_45298_22805.jpg

Waterside overview- pipe and flap gate with dense vegetation.

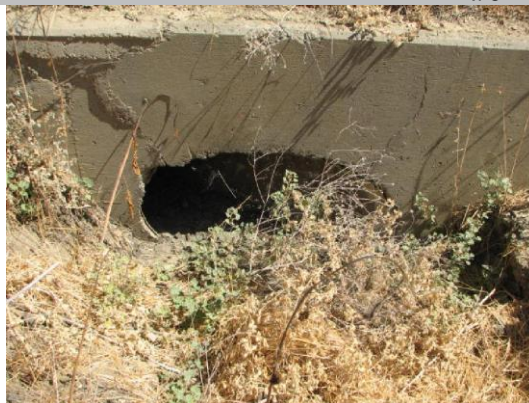
Photo 3 of 3 : UCIP_SP_2019_45285_22810.jpg

Landside view- soil and debris on mouth of the inlet pipe.

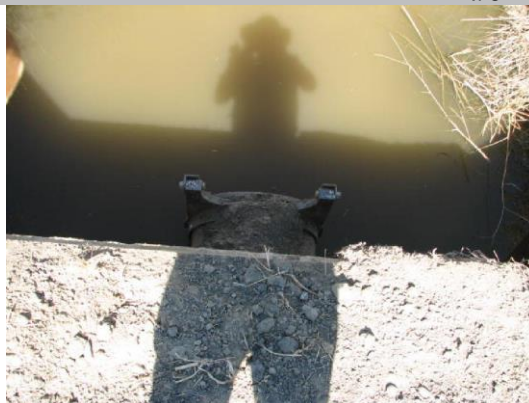
Photo 2 of 3 : UCIP_SP_2019_45302_22848.jpg

Waterside view-pipe and flap gate

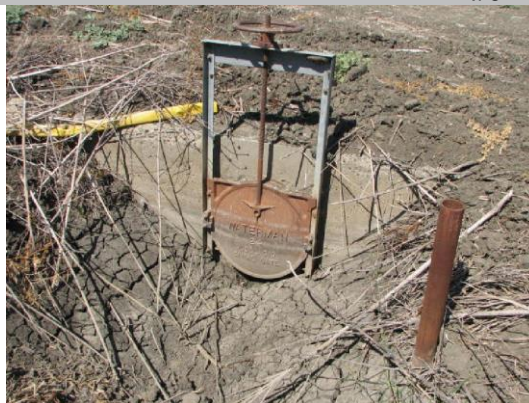
Photo 1 of 3 : UCIP_SP_2019_45305_22861.jpg

Landside view- inlet structure.

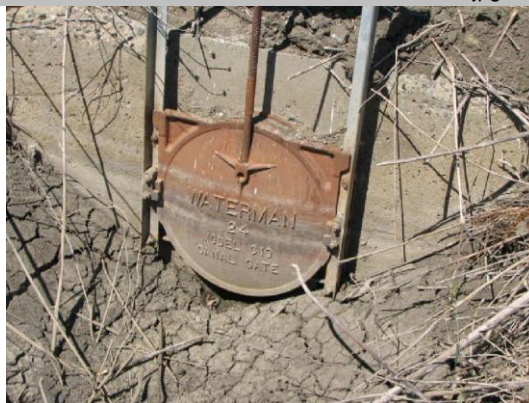
Photo 2 of 3 : UCIP_SP_2019_45305_22860.jpg

Landside view- concrete headwall and slide gate.

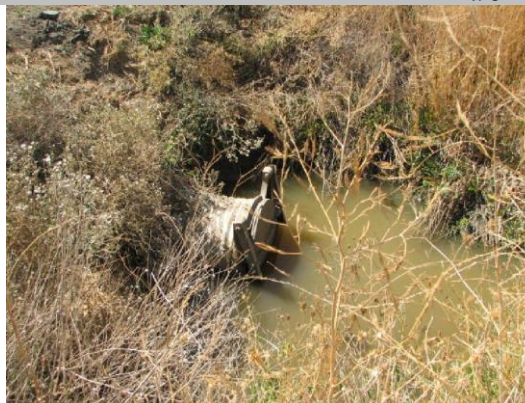
Photo 3 of 3 : UCIP_SP_2019_45306_22876.jpg

Waterside view- pipe and flap gate.
